HISTORIC PROPERTY INVENTORY FORM

Field Site No. 3701-D **OAHP No.** **Date Recorded** 31 Oct 1994
Site Name Historic Patrol Headquarters **Revised** 29 May 1998
Common
Field Recorder M.E. Crist, I.C. Lindsay, J.K. Keating
Owner's Name U.S. Department of Energy, Richland Operations Office
Address P.O. Box 550
City/State/Zip Code Richland, WA 99352

The 3701-D Building functioned as the Hanford Site Patrol Headquarters and Emergency Control Center for emergency situations, such as evacuations and criticalities. The main floor was used as the patrol officers headquarters where daily operations of the Hanford Patrol took place.

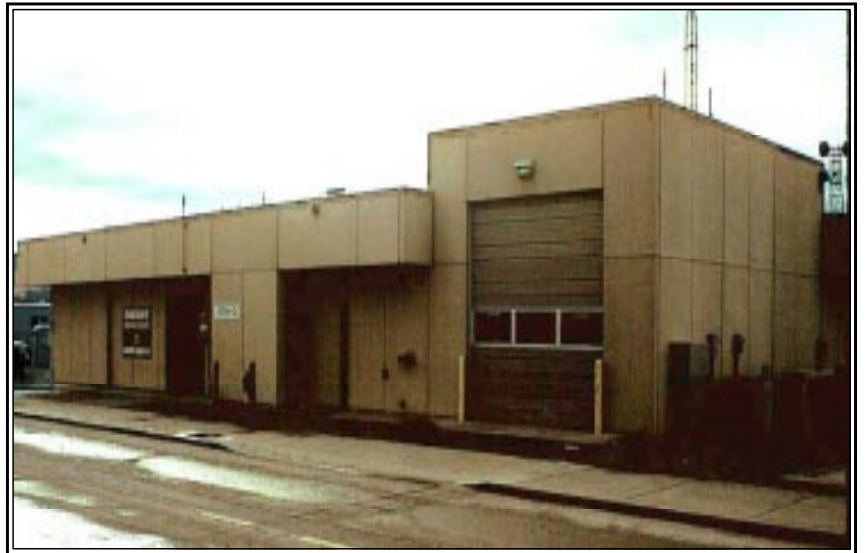
Photo at right; Roll 324, Frame 21
View of East facade.

The east wall is the main entrance to the building. On the north end of the east wall is a roll-up garage door; the door has a row of connected horizontal windows across the middle. The garage roof is slightly taller than the rest of the building and the cornice is absent here. South of the garage door on the east wall is a recessed double entry door, a fire alarm and fire hose. From the north wall, it is visible that the taller garage area extends west about halfway into the width of the building. The western half of the north elevation then returns to the height of the rest of the building and the cornice once again appears. The west wall contains a single entry door recessed near the north end. The south wall contains no distinct features, although extending from the base of the wall is a poured concrete pad chained off around the perimeter which measures 27 ft by 26 ft. This concrete pad is located over an underground addition made to the basement for the "war room" section of the Emergency Control Center. This room measures 24 ft. by 23 ft. and was not part of the original construction plan; it was added at an unknown date.
